Erweiterung einer Villa in Gauting

Villa expansion in Gauting

Architekten:

Unterlandstättner Architekten, München
Thomas Unterlandstättner

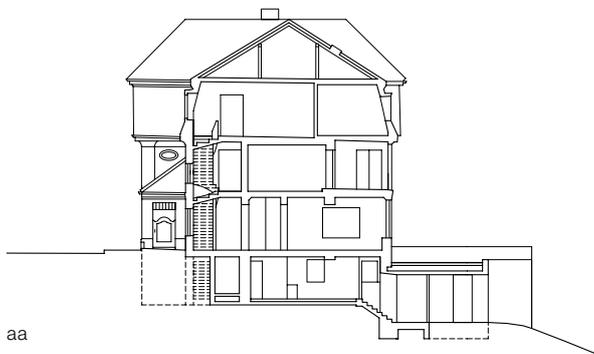
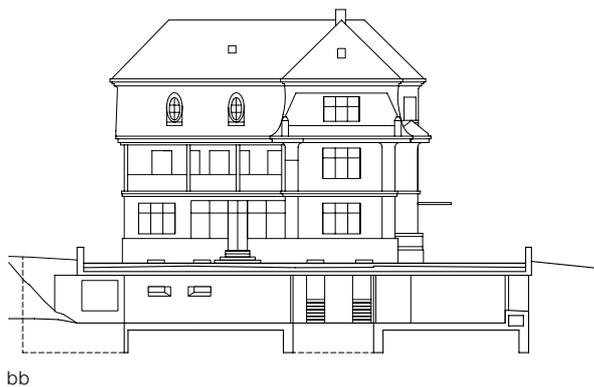
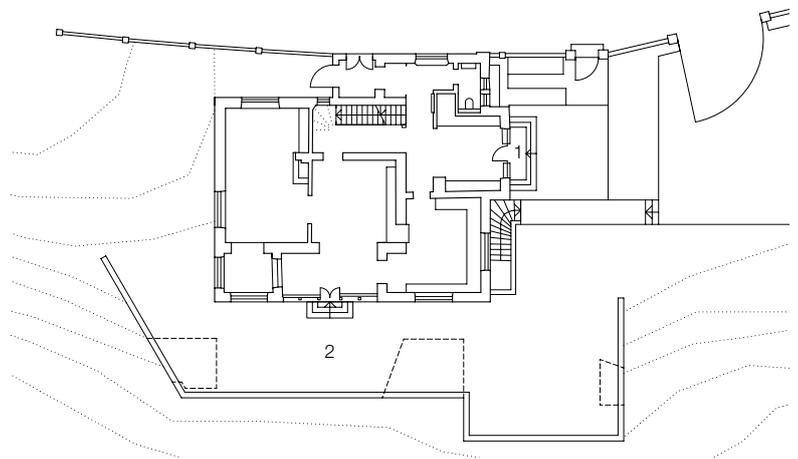
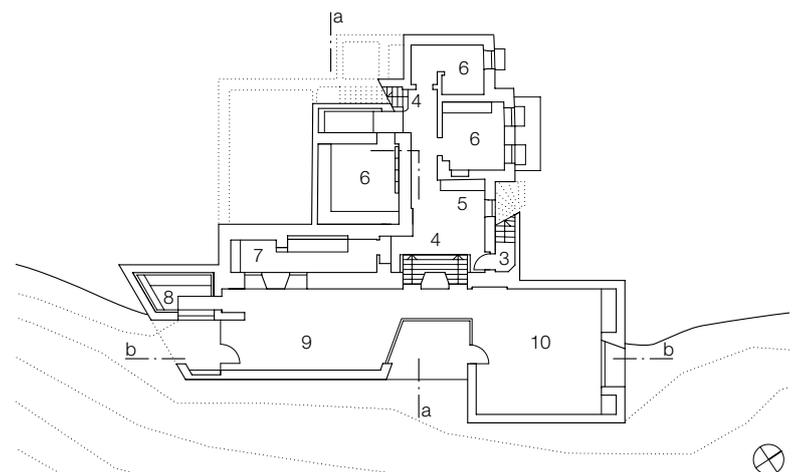
Schnitte • Grundrisse
Maßstab 1:400

Sections • floor plan
scale 1:400

- | | |

| 1 Eingang | 1 Entrance |
| 2 Terrasse | 2 Terrace |
| 3 Eingang Gäste-

appartement | 3 Entrance, guest
apartment |

| 4 interner Zugang

Verbindungstreppe | 4 Internal access via
staircase |

| 5 Küchenzeile | 5 Kitchen counter |
| 6 Keller (Bestand) | 6 Basement (existing) |
| 7 Badezimmer | 7 Bathroom |
| 8 Sauna | 8 Sauna |
| 9 Wohnbereich | 9 Living room |
| 10 Schlafbereich | 10 Bedroom |

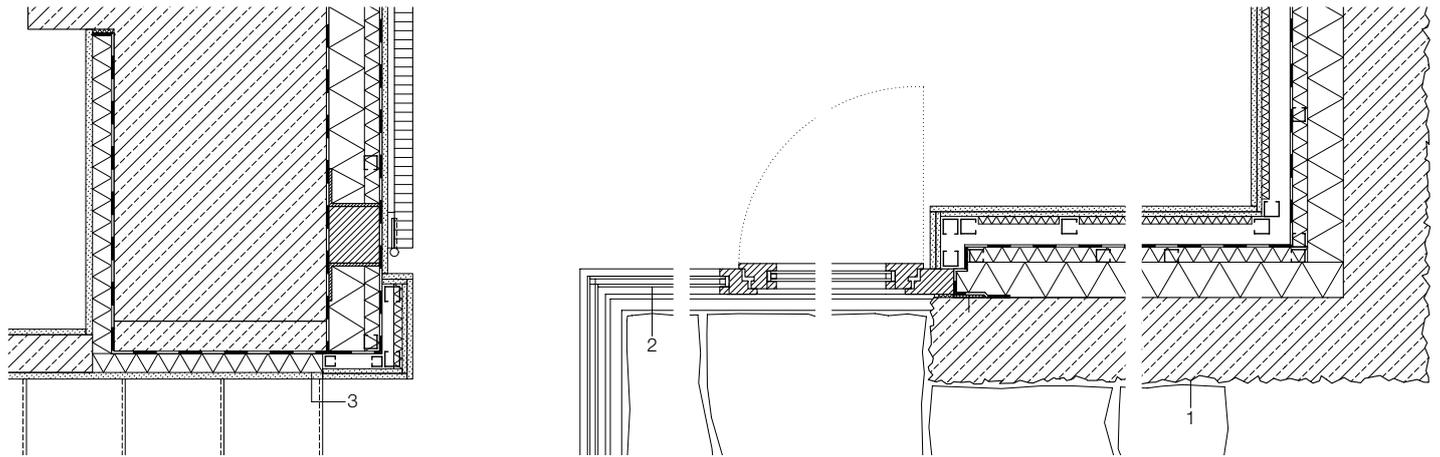
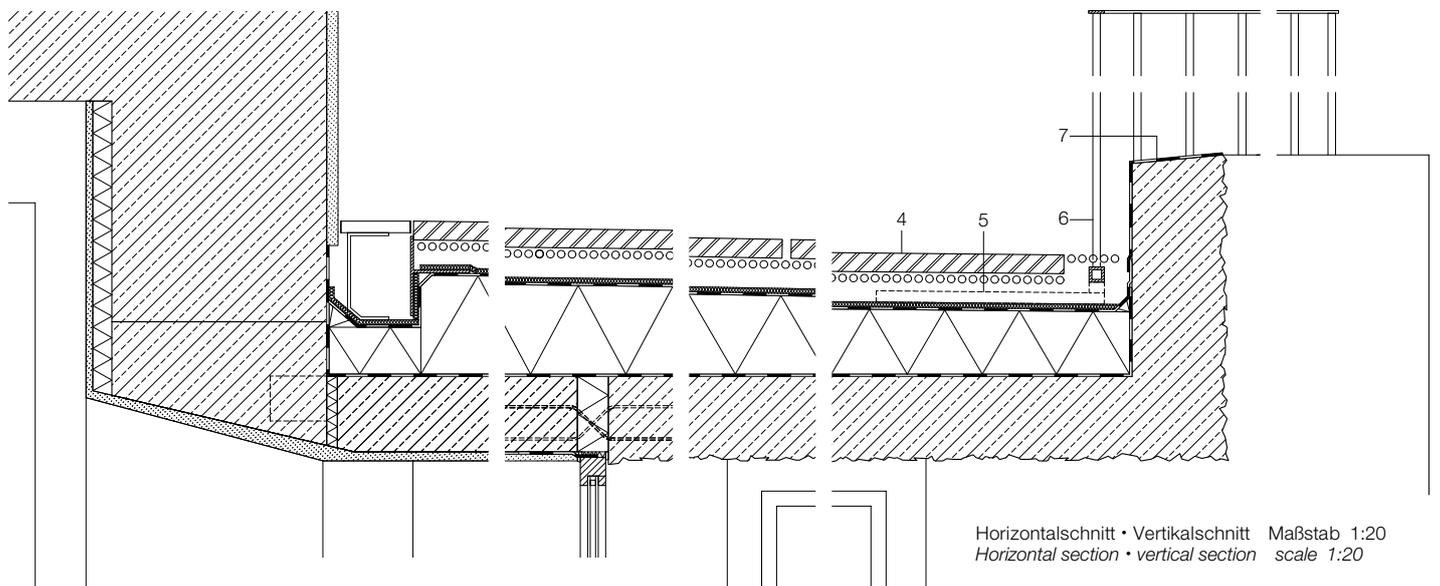
Horizontalschnitt • Vertikalschnitt Maßstab 1:20
Horizontal section • vertical section scale 1:20

- 1 Stahlbeton Oberfläche gespitzt 230 mm, Wärmedämmung Mineralwolle 140 mm, Dampfsperre, Installationsraum 55 mm, Trennwandfilz 20 mm Gipskarton 12,5 + 15 mm
- 2 Isolierverglasung 6 mm + 16 mm + 6 mm in Rahmen Eiche natur geölt
- 3 Wärmedämmung Schaumglas verputzt 50 mm
- 4 Wachenzeller Dolomit 50 mm, Kiesschüttung 80–140 mm, Verlegesplitt, Drainschicht, bituminöse Abdichtung zweilagig, Gefälledämmung, Dampfsperre bituminös, Stahlbeton gespitzt 230 mm
- 5 Befestigung Geländer Stahlplatte 600/750/30 mm
- 6 Geländer Stahlprofil Ø 20 mm
- 7 Abdichtung Flüssigkunststoff mit Einstreuung, farblich wie gespitzte Stahlbetonflächen
- 8 PU-Beschichtung weiß 5 mm, Heizestrich 65 mm, Wärmedämmung 50 mm, Polystyrol-Leichtbeton-Schüttung 30 mm, Abdichtung Bitumenbahn, Stahlbeton 200 mm

- 1 230 mm reinforced concrete, pointed surface
140 mm mineral wool thermal insulation
55 mm vapour barrier, services channel
20 mm felt liner, 12.5 + 15 mm gypsum board
- 2 toughened glass 6 mm + 16 mm + toughened glass 6 mm, oak frame, unfinished, oiled
- 3 50 mm foam glass thermal insulation, render finish
- 4 50 mm Wachenzell dolomite; 80–140 mm gravel crushed stone; drainage layer; 2-ply bituminous sealant; tapered insulation; bituminous vapour barrier; 230 mm reinforced concrete, sprayed surface
- 5 60/75/3 mm flat steel handrail connector
- 6 20 mm CHS handrail
- 7 liquid plastic sealant, aggregate fill, colour to match reinforced concrete surfaces
- 8 5 mm PU sealant, white; 65 mm heating screed
50 mm thermal insulation; 30 mm polystyrene lightweight concrete fill; bituminous sealant layer
200 mm reinforced concrete

23 cm starke Sichtbetonwand mit gespitzter, grobkörniger Oberfläche. Die manuelle Bearbeitung mit Pressluftgeräten überspielt dabei Schalungsstöße und Fassadenanker und führt so zu einem monolithischen Eindruck. Drei höhlenartige Einschnitte mit raumhoher Verglasung belichten die 120 m² große Wohnfläche des Anbaus, das Wechselspiel von Innen und Außen verleiht dem langgestreckten Appartement räumliche Vielfalt. Eine breite Treppe im Durchbruch der Kellerwand führt in den ebenfalls neu gestalteten Eingangsbereich der Gästewohnung. Die homogene Farbgestaltung in Weiß fasst neue und alte Elemente zusammen und bezieht auch das Einbaumobilien ein.

rock face: a 23 cm strong exposed concrete wall with a roughened, 'pointed' surface. It was manually treated with jackhammers, eroding manufacturing traces such as cast seams and facade anchor bolts holes, and leading to a monolithic impression.
